**THE DEPENDENCE OF MECHANICAL CHARACTERISTICS
OF WASPALOY AT 1000° - 1400°F
ON THE GAMMA PRIME PHASE
CASE FILE
COPY**

David J. Wilson and James W. Freeman

**THE UNIVERSITY OF MICHIGAN
College of Engineering
Department of Chemical and Metallurgical Engineering**

PERIODIC REPORT

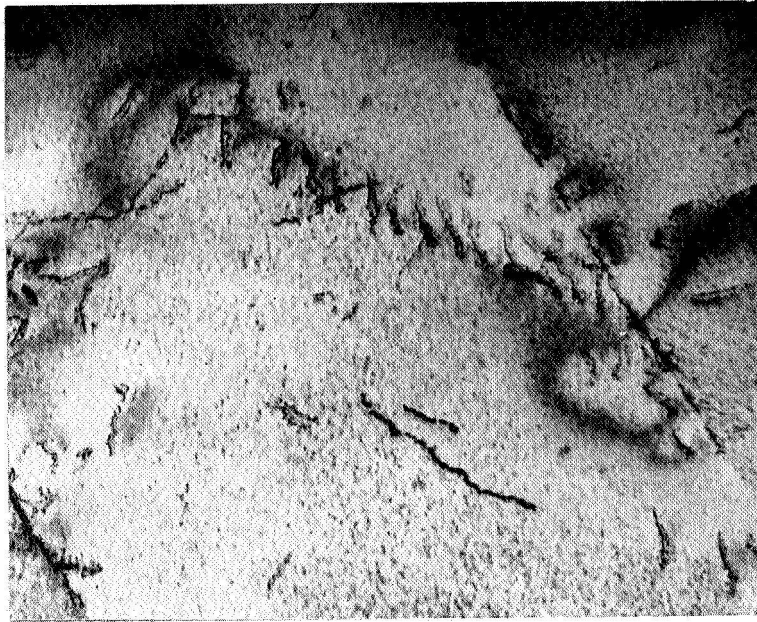
Transmission electron micrographs of Waspaloy, heat treated 1/2 hour at 1975°F, aged 16 hours at 1400°F and strained 2.3% at 1000°F. Dislocations are present in pile ups and are frequently "paired" to form superdislocations.

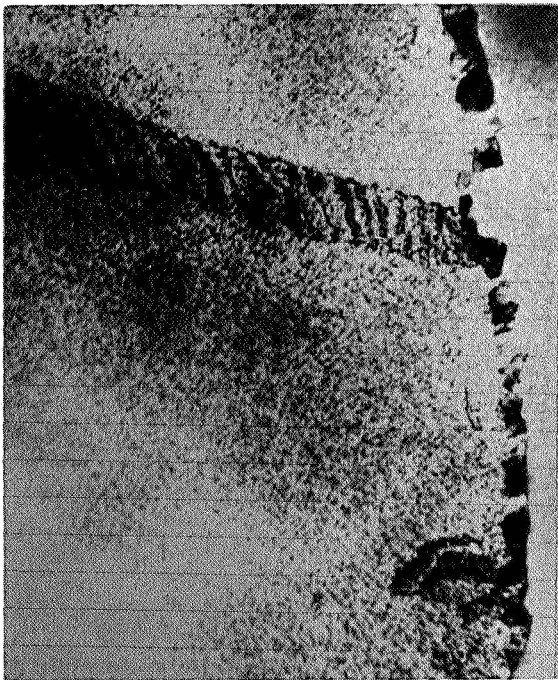
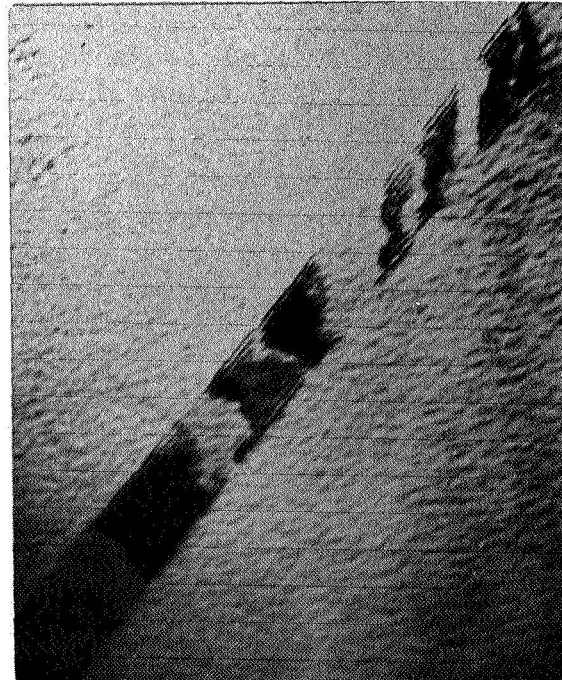
Thin-foil electron micrographs of Waspaloy, heat treated 1/2 hour at 1975°F, aged 16 hours at 1400°F and creep rupture tested at 1200° and 1300°F. Dislocations are present in pile ups and are in the main extended to form stacking fault ribbons. (Figures 16a, b - tested at 90 ksi and 1200°F, ruptured in 376 hours at 1.5% elongation; Figure 16c- tested at 80 ksi at 1300°F, ruptured in 64 hours at 1.7% elongation.)

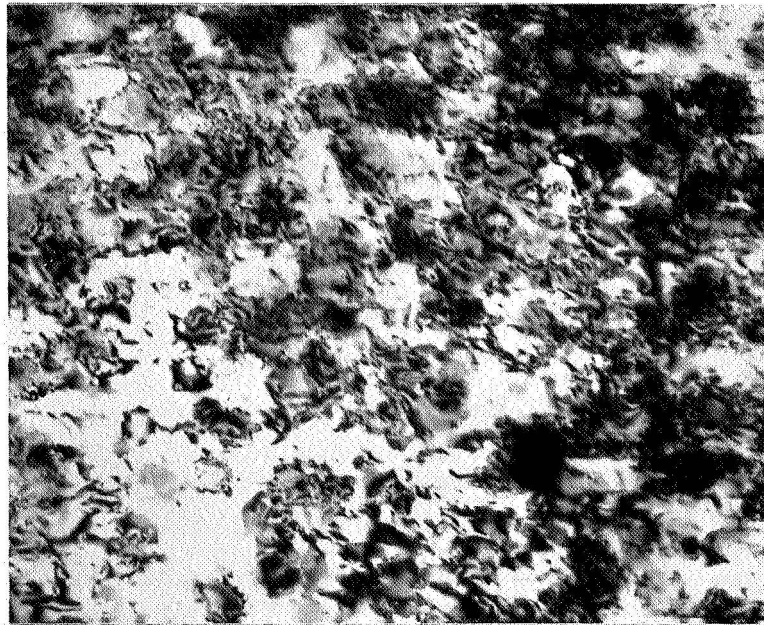
Transmission electron micrographs of Waspaloy, heat treated 1/2 hour at 1975°F, aged 10 hours at 1700°F and tensile tested at 1000°F (YS = 95 ksi, TS = 148 ksi, Elongation = 32%). The structures are highly deformed with a tendency for the deformation to be maximized on slip planes.
